EUSTON TOWER

Tree Survey & Arboricultural
Assessment

December 2024

**Survey Date: 6th September 2024
Report Date: 18th November 2024
Project no: 1993**

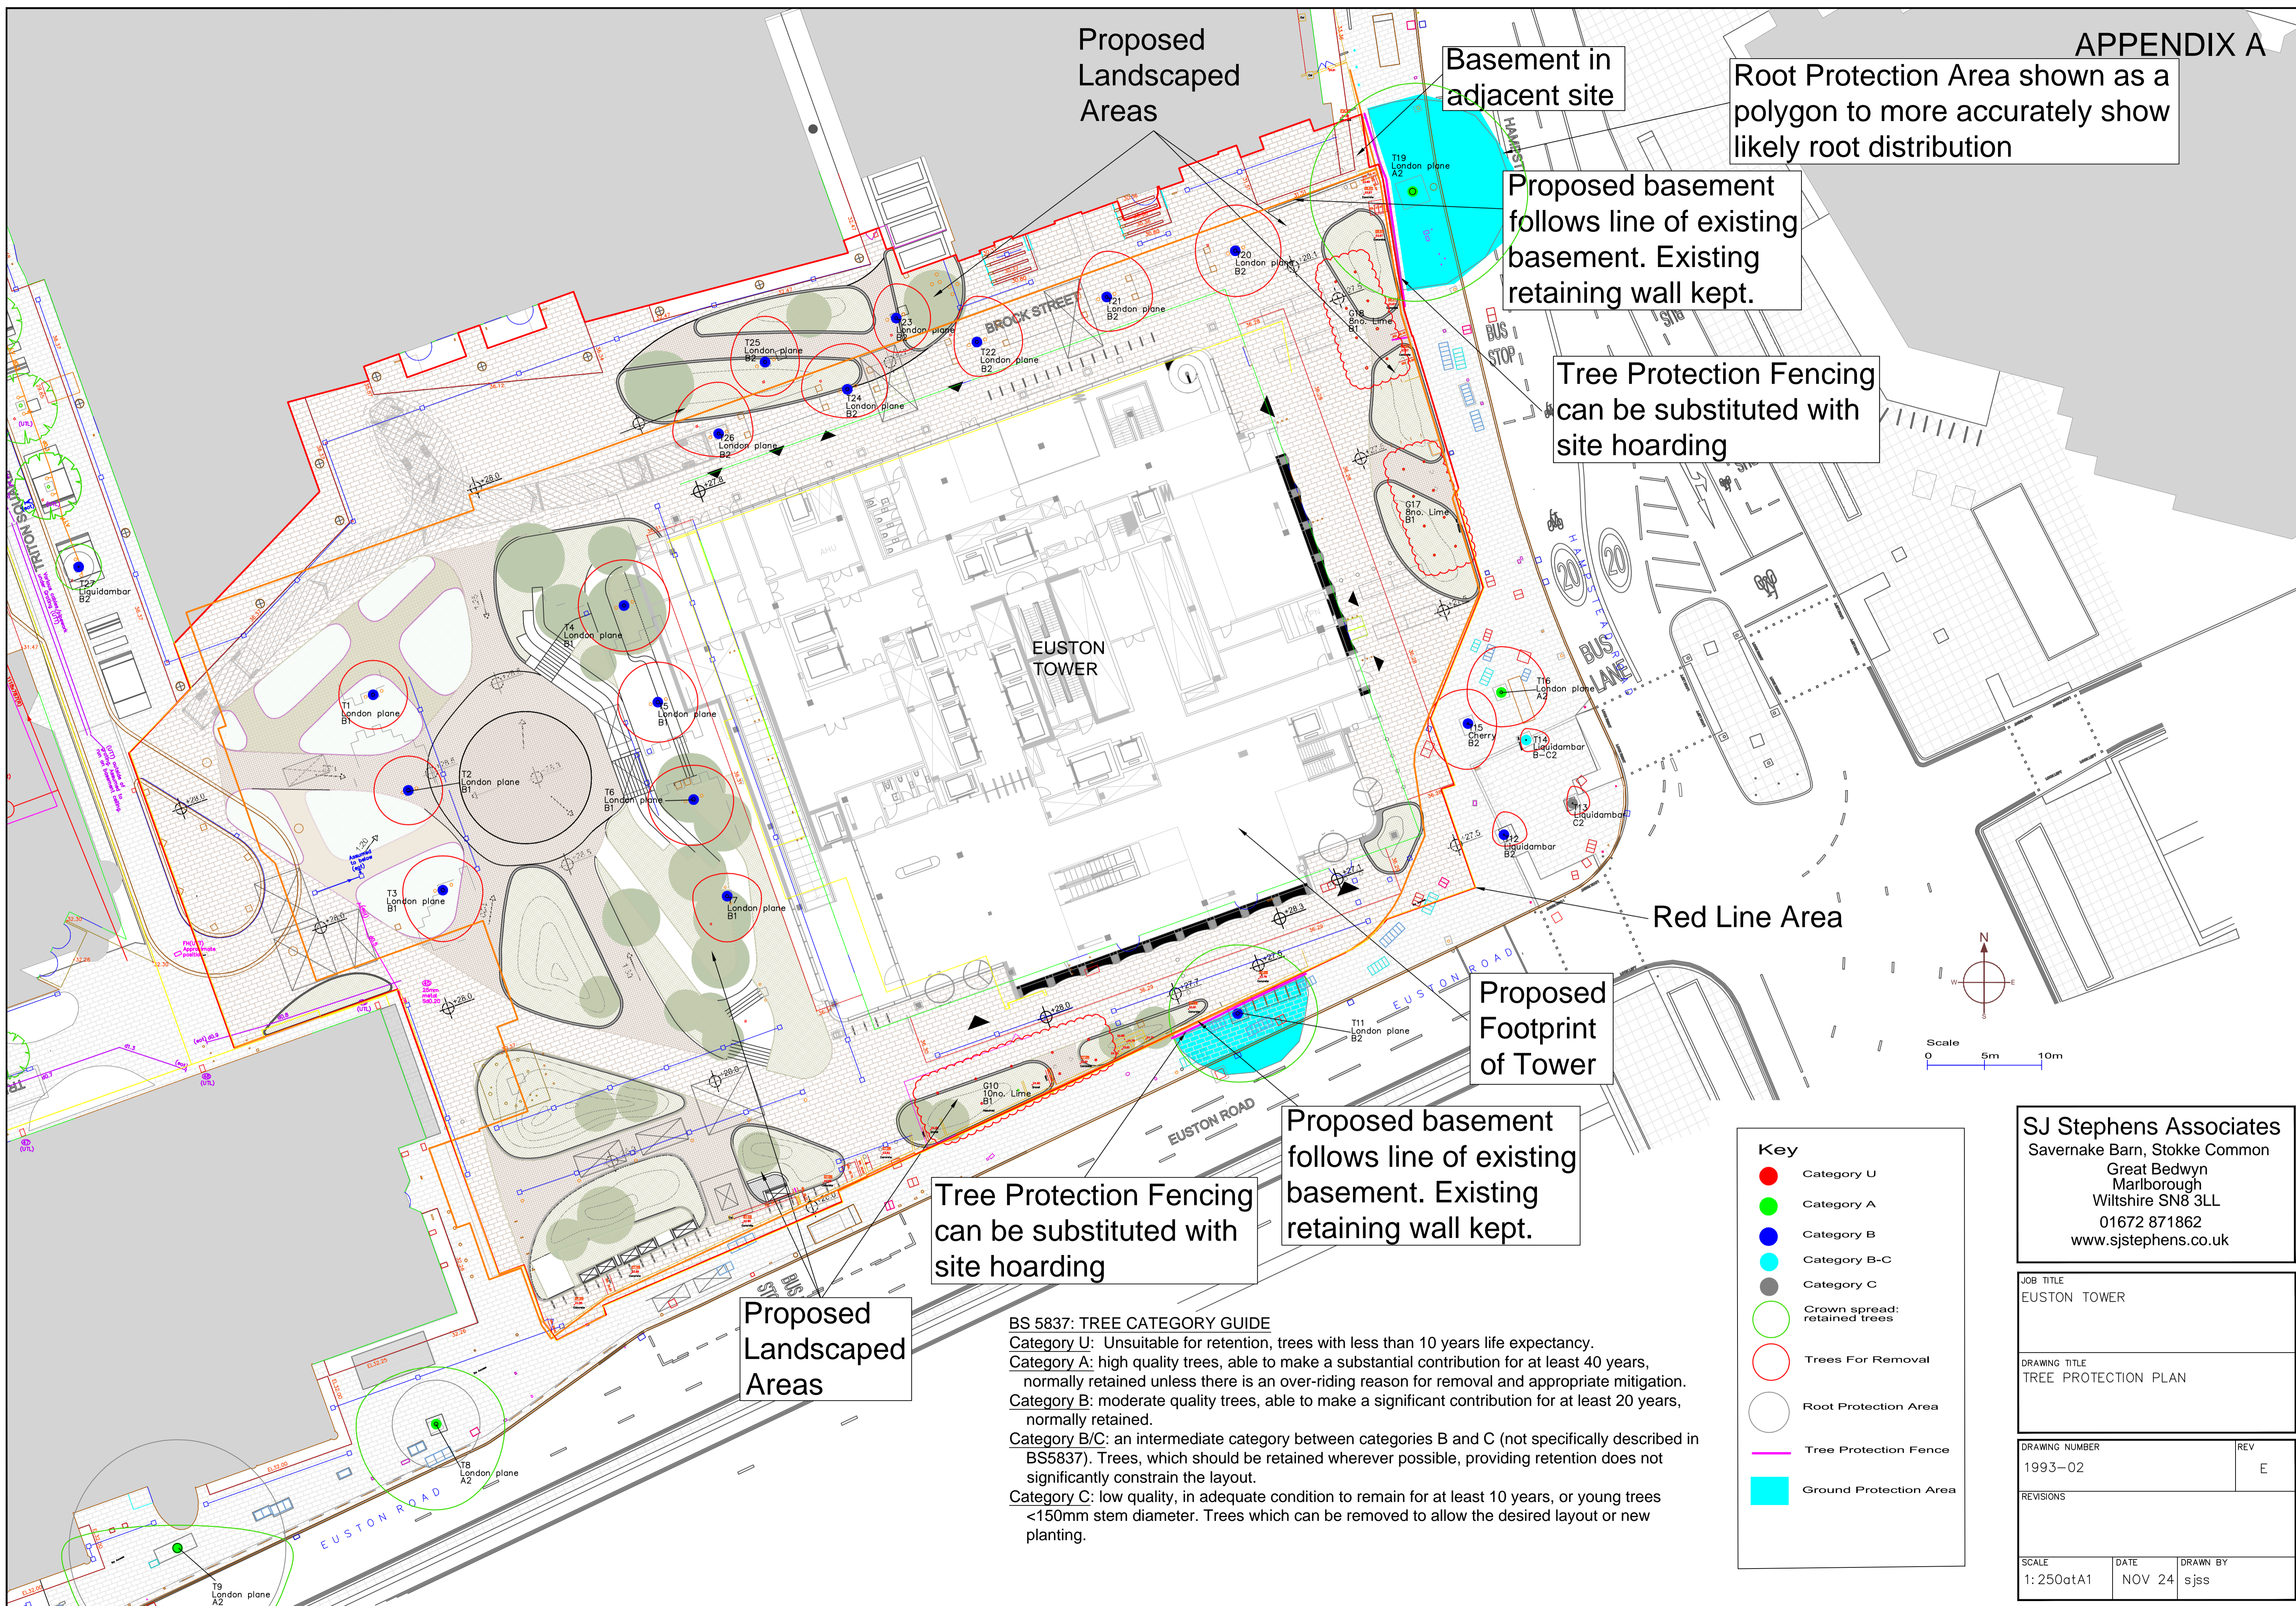
DRAWING TITLE
 TREE PROTECTION PLAN

Root Protection Area shown as a polygon to more accurately show likely root distribution

Proposed basement follows line of existing basement. Existing retaining wall kept.

Tree Protection Fencing can be substituted with site hoarding

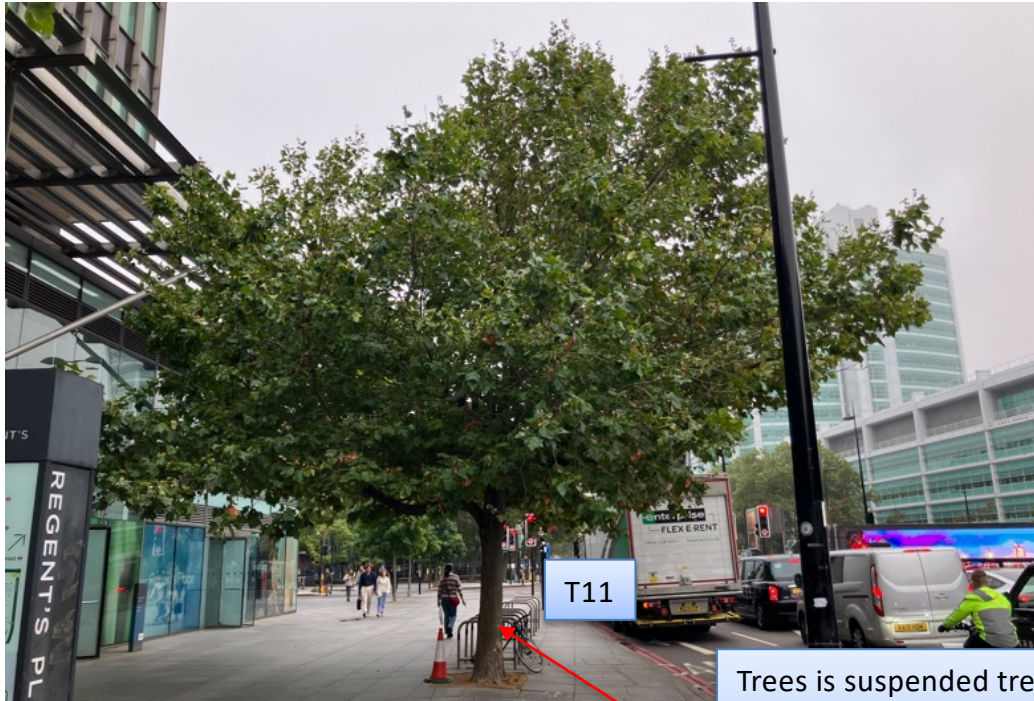
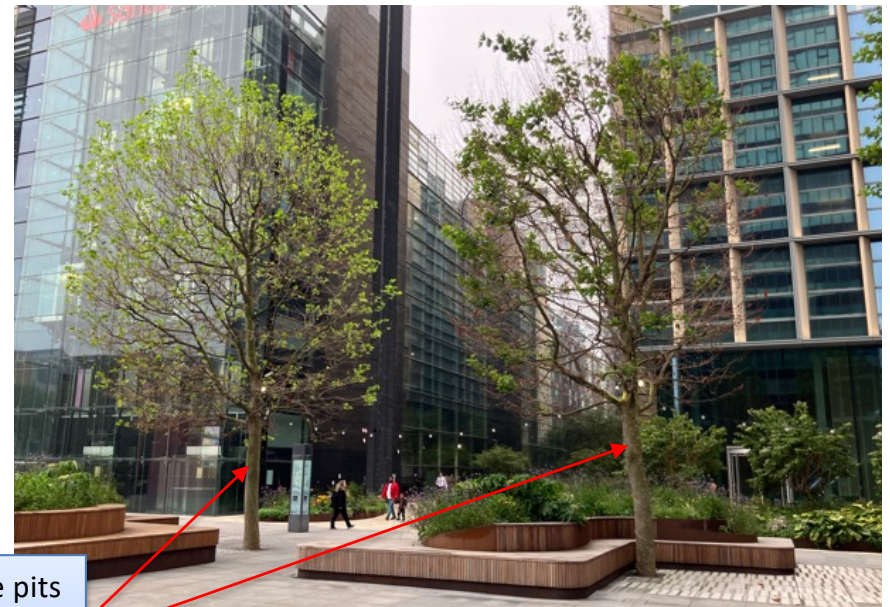
Trees is suspended tree pits showing early leaf fall, in contrast to trees growing In ground
